SORGEL COMMUNICATOR

SC-6 May 1977

Unusual Problems with WYE Connected, Three Phase Power Transformers

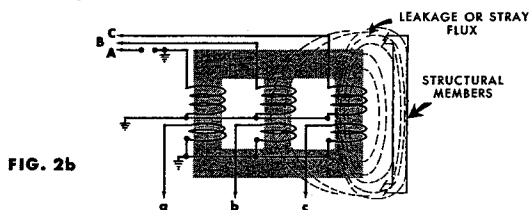
FIG. 2a

Assume we have a three phase, core type transformer (either dry or liquid filled), connected as in Fig. 2a. Fig. 2b shows only the external leakage flux pattern in a core type transformer for the unusual conditions to be explained later.

In a typical distribution system, with a primary neutral grounded as in 2a, the stage is set for a related problem

similar to the practical problem described in the previous paragraphs. Assume the main feed is overhead and during a storm a tree limb breaks Line A, and simultaneously grounds it on the load side of the break. Obviously no line current can flow in the shorted A phase primary winding now isolated from its power source. On a substantial distribution system, back-up protective equipment will not operate because the shorted winding does not create currents large enough in phases B or C to blow line fuses or to trip breakers.

However, the other two phases continue to create magnetic flux in their respective core legs but because of the shorted A phase winding, flux from the other two core legs is effectively blocked from entering the A core leg. Because the flux generated in B & C legs *must* return to the particular core leg in which it originated it is forced to find an exterior path such as indicated by the dotted lines, either through air or adjacent metal parts. The greatest percentage of these will find the path of lowest reluctance (least magnetic resistance) which will be the closest cabinet panels and structural steel. That such a condition is of no small moment is evidenced by actual field experiences wherein the structural members and panels are raised to an extreme heat condition actually causing them to weld together. We are aware of similar experiences in oil filled transformers in which tank heating was sufficient to cause severe paint blistering.

These two cases alone, among a variety of others that could be cited, clarifies why our recommendation is to counsel against a grounded wye primary connection unless the user will install sensitive protective equipment to clear all three phases when unusual vagaries of fate place a transformer into difficulty. A delta primary makes life so much easier.
