SORGEL COMMUNICATOR

SC-6 May 1977

Unusual Problems with WYE Connected, Three Phase Power Transformers

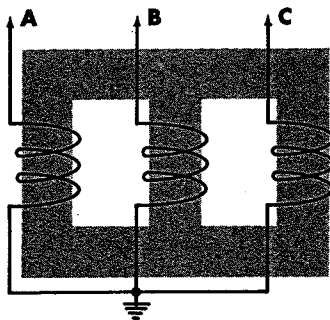
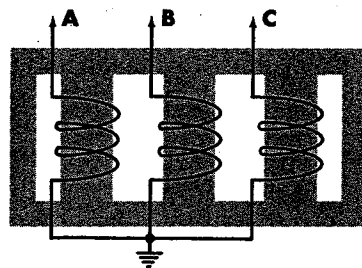
Of these, No. 1 and No. 4 are of the greatest import to the user. Reference to Fig. 1 will help to clarify the foregoing statements.
